**Flood Control Project Maintenance
Levee Inspections**

Fall 2015 Levee Maintenance Deficiency Summary Report

Sutter Maintenance Yard Maintenance Area 0013

Waterway			Bank	Unit Miles
Unit No. 01 Cherokee Canal			Right	18.19
	Spring (March - May)	Summer (June - August)	(September - November) Fall	Winter (December - February)
Unit Maintenance Rating (Fall Only)			A	
Date of Inspection	05/06/2015 - 05/06/2015		11/06/2015 - 11/06/2015	
DWR Inspector	Bob Duffey		Bob Duffey	
Accompanied By	Shawn Freitag Sutter Maintenance Yard		Shawn Freitag Sutter Maintenance Yard

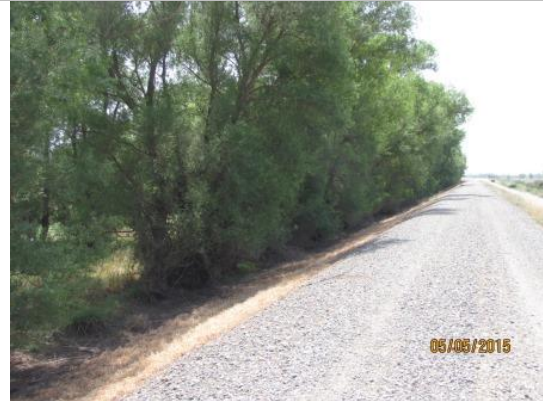
Photo 1 of 1 : FA_2015_MA0013_301_6_20150910_00002.jpg

LM Start	20.48	Rating **	M	Issue No.	6
LM End	20.75	Issue Type +	Ma	Location *	LS
Category	Earthen Levee			GPS Latitude/Longitude	
				Start	End
Item	Trim / Thin Trees			39.372724 °	39.370732 °
				-121.846022 °	-121.850282 °
DWR ID	DWR_MA0013_02_s_2013_6				
Action/Comments					
Trim trees to at least five feet above ground level.					
Inspector Comments: Trim the trees 5 feet to allow visibility.

Trim the trees 5 feet to allow visibility along the landside slope.

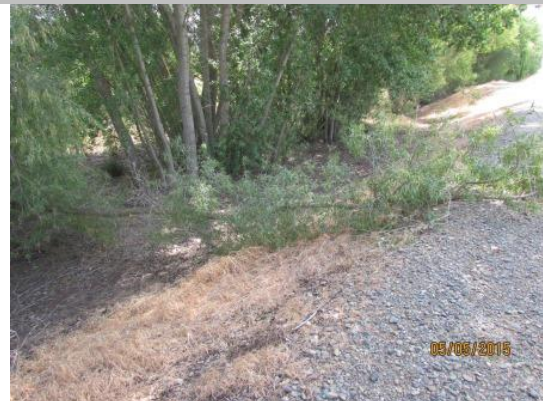
Photo 1 of 1 : FA_2015_MA0013_301_52_20150910_00012.jpg

LM Start	20.65	Rating **	M	Issue No.	52
LM End	20.65	Issue Type +	Ma	Location *	LS
Category	Earthen Levee			GPS Latitude/Longitude	
				Start	End
Item	Encroachments			39.371433 °	39.371433 °
				-121.848753 °	-121.848753 °
DWR ID	DWR_MA0013_02_s_2014_52				
Action/Comments					
Tree or limb					
Inspector Comments: Remove the tree limbs from the landside slope and toe.

View of the trees limbs along the landside slope and toe.

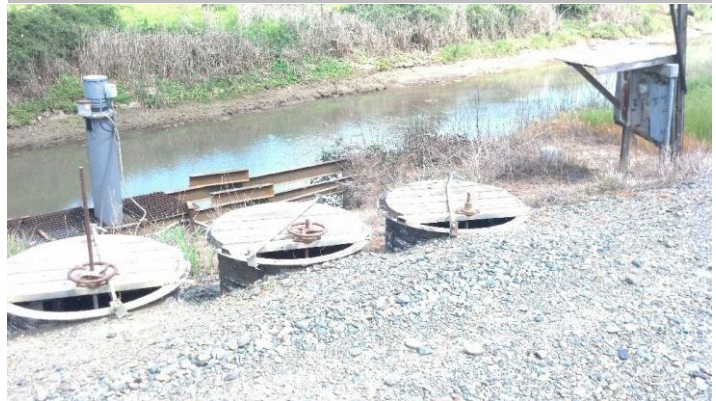
Photo 1 of 3 : UCIP_FA_2015_3763.jpg

Action/Comments					
Inspector Comments: FS_ID:46253					
DS_ID:16383					
EP_NO: N/A					
FS_HLM: 21.001					
Repair Type: Urgent					
Crossing Status: Found					
UCIP Comments: 6/30/2015 Crossing has not been repaired yet. pipe ends still showing heavy signs of rust and corrosion. LS pipe collars severely damaged--section missing at flapgate. Buried section of pipe could be in the same condition. Crossing needs to be repaired; will need to coordinate with applicant. WS slide gate handle missing. 7/8/2013 Same as last inspection. 12/4/2013 Same as last inspection. 5/28/2014 Same as last inspection.					
FIELD_STRUCT_DESC: 1 of 3: 16-inch steel pipes encased in reinforced concrete through the levee, 9.7 feet below the crown. Concrete "U" headwall on both ends. Slide gates on corrugated metal pipe risers on the waterward slope. Pump structure on the waterward end (USACE-1960). This entry matches the Drainage or Irrigation Structure referenced in O&M manual (HLM 21.00).

Corrugated metal pipe risers with slide gates located on WS slope.

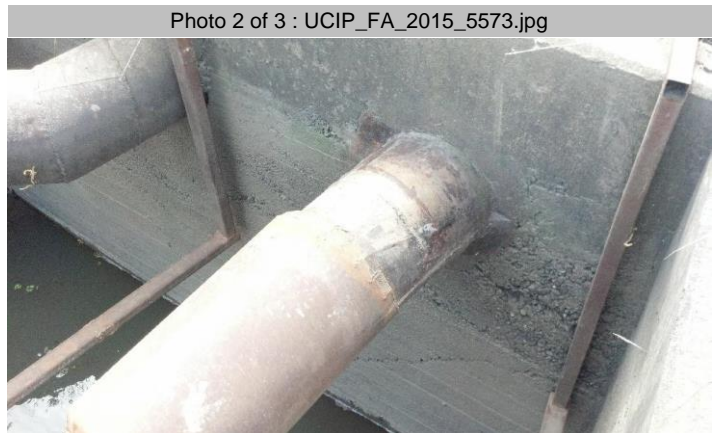
Action/Comments					
Inspector Comments: FS_ID:46255					
DS_ID:17185					
EP_NO: N/A					
FS_HLM: 21.002					
Repair Type: Urgent					
Crossing Status: Found					
UCIP Comments: 6/30/2015 Crossing has not been repaired yet. pipe ends still showing heavy signs of rust and corrosion. Sink hole present on WS. LS pipe collars severely damaged--section missing at flapgate. Crossing needs repair. Need to coordinate with owner. 7/8/2013 Same as last inspection. 12/4/2013 Same as last inspection. 5/28/2014 Same as last inspection.					
FIELD_STRUCT_DESC: 3 of 3: 16-inch steel pipe encased in reinforced concrete through the levee, 9.7 feet below the crown. Concrete "U" headwall on both ends. Slide gates on corrugated metal pipe risers on the waterward slope. Pump structure on the waterward end (USACE-1960). This entry matches the Drainage or Irrigation Structure referenced in O&M manual (HLM 21.00).

View of Pipe 3 of 3 from WS headwall.

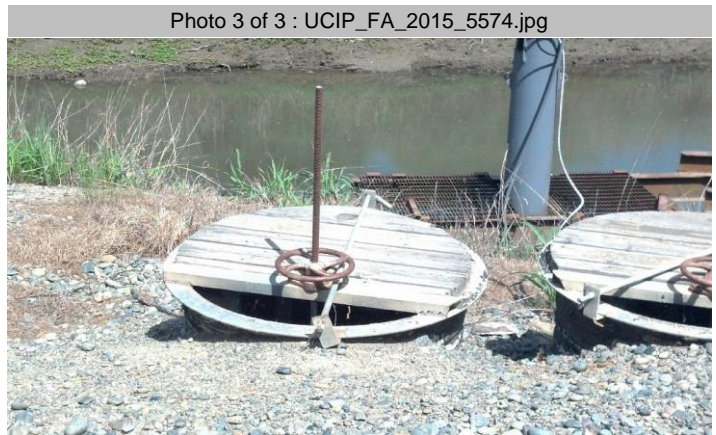
LM Start	20.76	Rating **	U	Issue No.	945 (cont)
LM End	20.76	Issue Type +	En	Location *	LS
Category	Supplemental			GPS Latitude/Longitude	
				Start	End
Item	DWR UCIP Field Study			39.370679 °	39.370679 °
				-121.850500 °	-121.850500 °
DWR ID					
Action/Comments					
Inspector Comments: FS_ID:46255 DS_ID:17185 EP_NO: N/A FS_HLM: 21.002 Repair Type: Urgent Crossing Status: Found UCIP Comments: 6/30/2015 Cossing has not been repaired yet. pipe ends still shwoing heavy signs of rust and corrosion.Sink hole present on WS. LS pipe collars severely damaged--section missing at flapgate. Crossing needs repair. Need to coordinate with owner.7/8/2013 Same as last inspection.12/4/2013 Same as last inspection.5/28/2014 Same as last inspection. FIELD_STRUCT_DESC: 3 of 3: 16-inch steel pipe encased in reinforced concrete through the levee, 9.7 feet below the crown. Concrete "U" headwall on both ends. Slide gates on corrugated metal pipe risers on the waterward slope. Pump structure on the waterward end (USACE-1960). This entry matches the Drainage or Irrigation Structure referenced in O&M manual (HLM 21.00). FS Date: 07/16/2015

View of corrugated metal pipe for pipe 3 of 3.

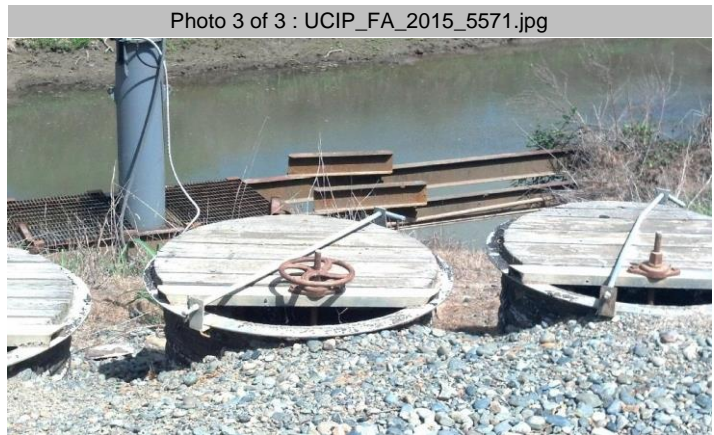
LM Start	20.76	Rating **	U	Issue No.	946 (cont)
LM End	20.76	Issue Type +	En	Location *	LS
Category	Supplemental			GPS Latitude/Longitude	
				Start	End
Item	DWR UCIP Field Study			39.370679 °	39.370679 °
				-121.850500 °	-121.850500 °
DWR ID					
Action/Comments					
Inspector Comments: FS_ID:46254 DS_ID:17014 EP_NO: N/A FS_HLM: 21.002 Repair Type: Urgent Crossing Status: Found UCIP Comments: 6/30/2015 Crossing has not been repaired yet. pipe ends still showing heavy signs of rust and corrosion. LS pipe collars severely damaged--section missing at flapgate. Crossing needs repair. Will need to coordinate with owner. 7/8/2013 Same as last inspection. 12/4/2013 Same as last inspection. 5/28/2014 Same as last inspection. FIELD_STRUCT_DESC: 2 of 3: 16-inch steel pipe encased in reinforced concrete through the levee, 9.7 feet below the crown. Concrete "U" headwall on both ends. Slide gates on corrugated metal pipe risers on the waterward slope. Pump structure on the waterward end (USACE-1960). This entry matches the Drainage or Irrigation Structure referenced in O&M manual (HLM 21.00). FS Date: 07/16/2015

Riser for pipe 2 of 3.

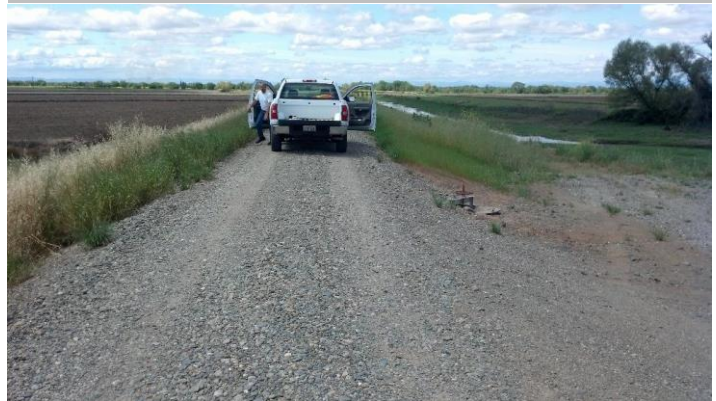
Photo 1 of 3 : UCIP_FA_2015_5575.jpg

UCIP Comments: 6/30/2015 Pipe is currently undergoing repairs. Not sure what all is planed to be fixed but will update the photos and inspection report with new details when its completed.Needs repair. Internal piping, severe corrosion. Debris present--rusted pipe stockpiled on LS slope. Limited inspection on WS and LS slopes due to dense vegetation. Need photos of cleared WS & LS slopes. This crossing was listed in the USACE Periodic Inspection report as Corp's inspect ID# USACE_CESPK_M13E_2011_p_0234 for no WS gate but sluice gate present.7/8/2013 Pipe appears to have been repaired. Need to talk to inspections and supervisor to find out more deatils on repair.12/4/2013 Same as last inspection.5/28/2014 Same as last inspection.

Overview of crossing looking downstream.

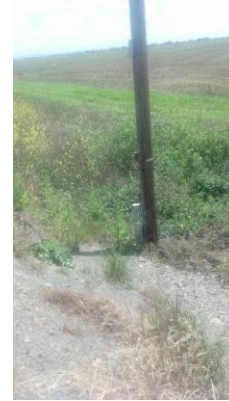
Photo 1 of 1 : UCIP_FA_2015_5492.jpg

Inspector Comments: FS_ID:46264
DS_ID:16374
EP_NO: N/A
FS_HLM: 22.114
Repair Type: Non-Urgent
Crossing Status: Indicator Found
UCIP Comments: 6/30/2015 same as last inspection. Unauthorized Encroachment. This crossing is listed multiple times in the USACE Periodic Inspection report as USACE_CESPK_M13E_2011_p_0307, 0315, 0317, 0318 for slope failure on LS hinge. DWR-Flood Maintenance Office records shows that CVFPB has requested AT&T to remove conduit in June 2, 2009 letter. LMA working with CVFPB to resolve. 7/8/2013 Same as last inspection. 12/4/2013 Same as last inspection. 5/28/2014 Same as last inspection.
FIELD_STRUCT_DESC: Illegal encroachment. Underground telephone cable through the levee. Depth unknown. (AT&T) START latitude 39.36210336, longitude -121.8678207 END latitude 39.35458541, longitude -121.8823409. Line extends from Gridley Colusa Highway to the south end of project levee along LS shoulder & levee crown hinge point. Levee sloughs along cable trench after heavy rains.

View of utility line located on LS toe.

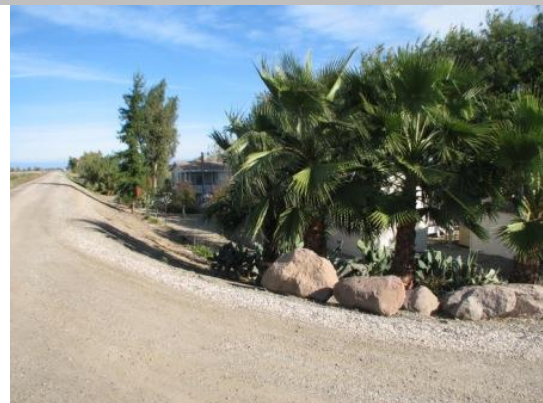
Photo 1 of 1 : FA_2015_MA0013_301_4_20150910_00001.jpg

LM Start	22.13	Rating **	M	Issue No.	4
LM End	22.13	Issue Type +	En	Location *	LS
Category	Earthen Levee			GPS Latitude/Longitude	
				Start	End
Item	Vegetation			39.359982 °	39.359982 °
				-121.871958 °	-121.871958 °
DWR ID	DWR_MA0013_02_s_2012_4

Landscaping

View of landscaping along the toe.

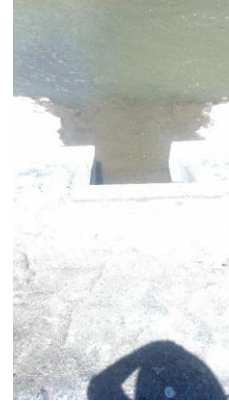
Photo 1 of 3 : UCIP_FA_2015_5652.jpg

LM Start	22.15	Rating **	M	Issue No.	949
LM End	22.15	Issue Type +	En	Location *	LS
Category	Supplemental			GPS Latitude/Longitude	
				Start	End
Item	DWR UCIP Field Study			39.359827 °	39.359827 °
				-121.872300 °	-121.872300 °
DWR ID					
Action/Comments					
Inspector Comments: FS_ID:46267 DS_ID:16391 EP_NO: N/A FS_HLM: 22.4 Repair Type: Non-Urgent Crossing Status: Found UCIP Comments: 6/30/2015 Still unable to locate the LS headwall and pipe end.Unable to locate LS headwall. Need photo of LS headwall during next inspection.7/8/2013 Same as last inspection. Unable to locate LS headwall.12/4/2013 Same as last inspection.5/28/2014 Same as last inspection. FIELD_STRUCT_DESC: 30-inch corrugated metal pipe through the levee, 15.3 feet below the crown. Flap gate on the waterward end. Concrete "U" headwalls on both ends. This pipe runs on an angle through the levee, then underground along the landward slope to levee mile 22.39 where it enters a ditch on the landward side (USACE-1960). FS Date: 07/16/2015

View of WS slope looking from WS headwall to levee crown.

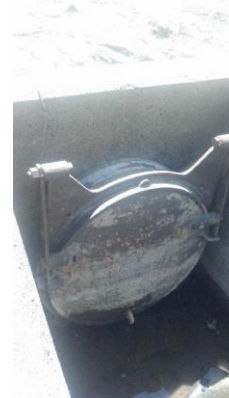
Photo 2 of 3 : UCIP_FA_2015_5653.jpg

View of flap gate on WS.

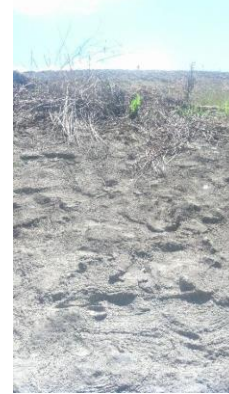
Photo 3 of 3 : UCIP_FA_2015_5654.jpg

LM Start	22.15	Rating **	M	Issue No.	949 (cont)
LM End	22.15	Issue Type +	En	Location *	LS
Category	Supplemental			GPS Latitude/Longitude	
				Start	End
Item	DWR UCIP Field Study			39.359827 °	39.359827 °
				-121.872300 °	-121.872300 °
DWR ID					
Action/Comments					
Inspector Comments: FS_ID:46267 DS_ID:16391 EP_NO: N/A FS_HLM: 22.4 Repair Type: Non-Urgent Crossing Status: Found

View of WS slope looking from WS headwall to levee crown.

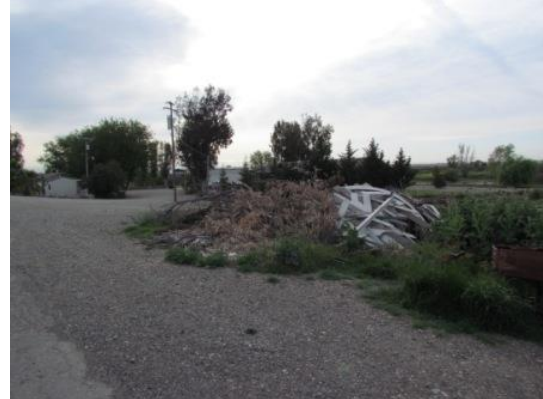
Photo 1 of 1 : FA_2015_MA0013_301_8_20150910_00004.jpg

LM Start	22.16	Rating **	M	Issue No.	8
LM End	22.16	Issue Type +	Ma	Location *	LS
Category	Earthen Levee			GPS Latitude/Longitude	
				Start	End
Item	Encroachments			39.359707 °	39.359707 °
				-121.872555 °	-121.872555 °
DWR ID	DWR_MA0013_02_s_2012_8				
Action/Comments					
Prunings

View of the debris & prunings.

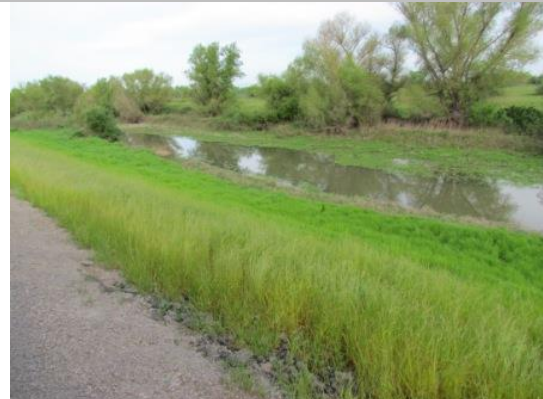
Photo 1 of 1 : FA_2015_MA0013_301_7_20150910_00003.jpg

LM Start	22.58	Rating **	M	Issue No.	7
LM End	22.60	Issue Type +	Ma	Location *	LS
Category	Earthen Levee			GPS Latitude/Longitude	
				Start	End
Item	Erosion / Bank Caving			39.356498 °	39.356303 °
				-121.879030 °	-121.879417 °
DWR ID	DWR_MA0013_02_s_2012_7				
Action/Comments					
Note and monitor erosion site.

View of the erosion along the canal.
